RE: April 2004 Monthly Report
1.5 Mile Reach Removal Action
GE-Pittsfield/Housatonic River Site

Figure 1- 1.5 Mile Removal Action Site Map

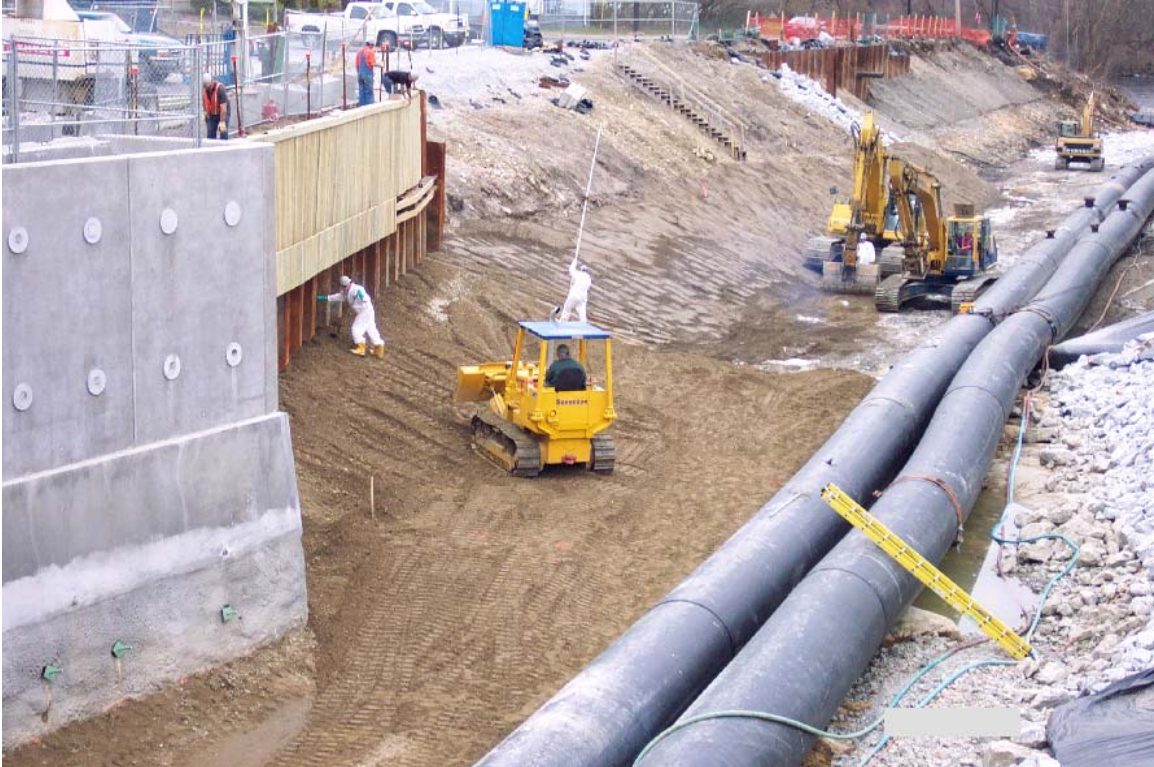
Photograph 1 – Riverbank Backfill Activities in Cell 14E; Placement of Structural Fill Sub-grade for the Articulated Concrete Block

During the fourth week of April, backfilling activities on the east side of Cells 14 and 15 continued. The placement of the structural fill, grading and compaction in the first 185 feet of the riverbed and riverbank was completed. Those areas of the riverbed and riverbank were then covered with geotextile, ACB was placed and Polyethylene (PET) cable was installed between the blocks. The ACB was then anchored with Manta Ray Anchors. The anchors were hammered down to a depth of approximately three feet and pulled in place by using a hydraulic force of approximately 1.5 to 2.5 tons. The anchors were locked in place, cut below the top of

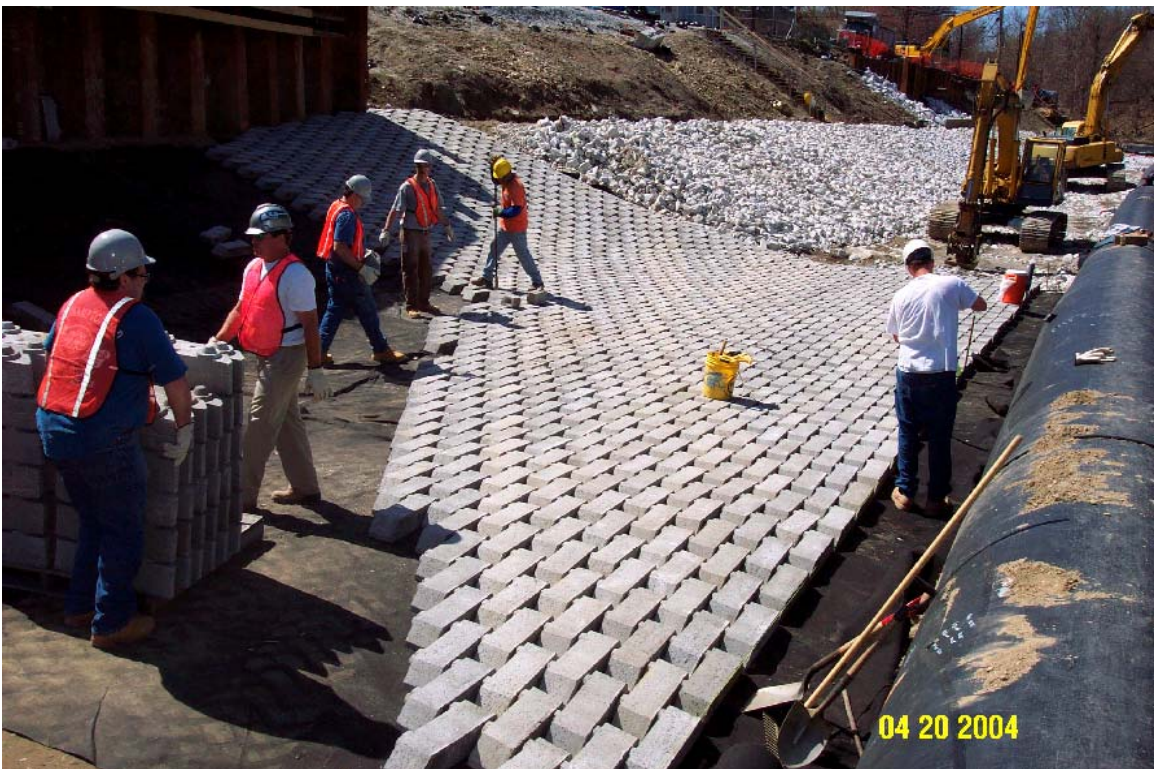
Photograph 2 –Installation of the Articulated Concrete Block in Cell 14E

ACB, and grout was then applied to attach each anchor to the ACB. At the upstream interface of the ACB and the rip rap, the ACB was anchored down with a two-foot layer of concrete. The installation of the backfill in the remaining 345 feet of the riverbed and riverbank was completed as well. The riverbank was backfilled with common fill or structural fill, a six inch layer filter material and an eighteen inch layer of 12-inch rip rap up to either elevation 973 or 974.2. The remaining 345 feet of the riverbed in Cells 14 and 15 was backfilled with a layer of filter material in low lying areas followed by a layer of 12-inch rip rap. Areas of the riverbed where bedrock was encountered at very shallow depths was left with the bedrock exposed. Backfilling of the riverbank above the ACB (elevation 974.2 and 975.5) and above the rip rap (elevation 973 or 974.2) was initiated. The riverbank in those areas was backfilled with common fill in one – foot lifts, compacted and tested to meet the 90% compaction requirement.

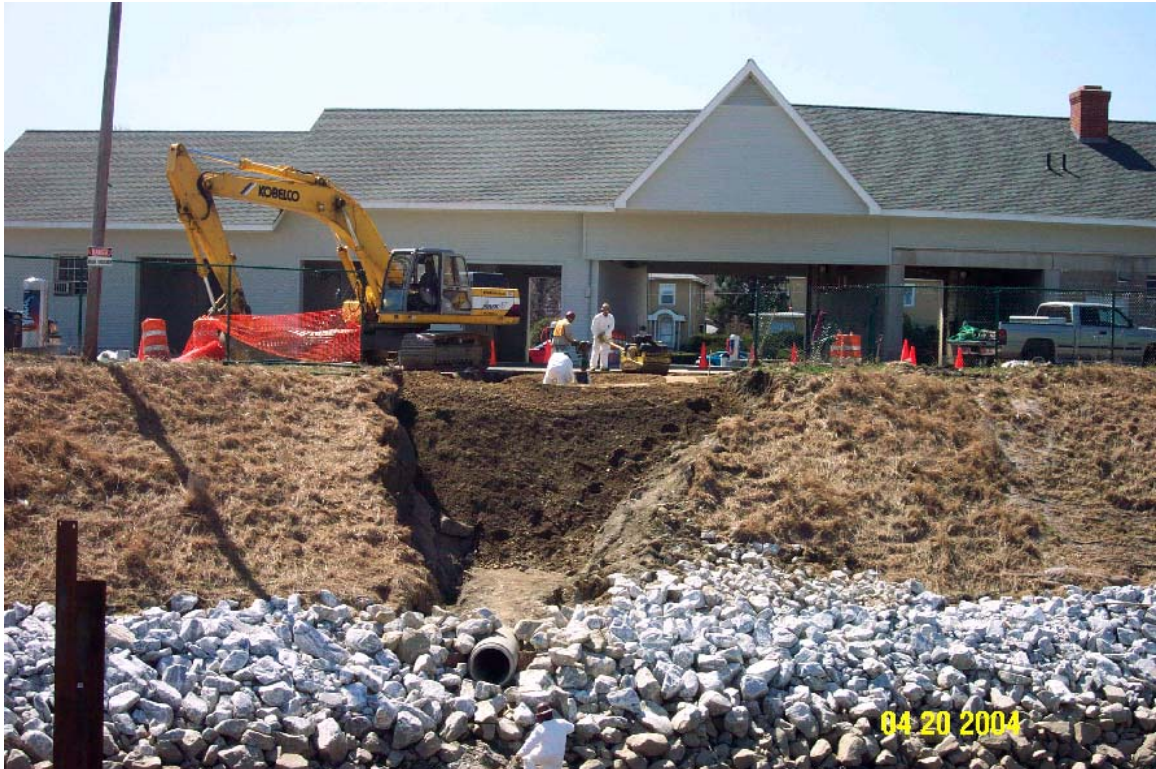
Photograph 3 – Repair of the City Storm Drain on Parcel I8-23-6

The existing pipe, which was severely corroded and partially collapsed, was removed. The excavation bottom was re-graded, compacted and processed gravel was installed as sub-base material. A new 24-inch RCP pipe was installed at an elevation designated by survey sub-contractor. During the installation of the new pipe it was observed that the terracotta pipe to which the new pipe was to be connected was in substandard condition. The City of Pittsfield Public Works Department was notified to inspect the pipe. It was agreed upon that any additional repairs, if any, to the remaining terracotta pipe would not be EPA's responsibility. The City also concurred with the EPA's proposed design connection with the existing terracotta pipe. A 3-foot section of M12 ABS corrugated pipe was installed around the end of the existing terracotta pipe, both pipes were connected to the newly installed manhole and backfilling and compaction activities continued.

The 24-inch storm water outfall repairs on Parcel I8-23-6 continued. The area of the pipe repair on the top of the parking lot was backfilled with structural fill, compacted in six-inch lifts to meet the 90% compaction requirements. The excavation area on the riverbank was backfilled with common fill and a new layer of cellular geoweb was installed on the riverbank. The previously removed and stockpiled rip rap was placed back on the riverbank. A concrete footing was poured for the vacuum and the electrical lines were reconnected. The area was prepared for paving. All the clean up and remaining excavated material was transported to Area 64D stockpile management area (approximately 2.5cy).

The 24-inch storm water outfall repairs on Parcel I8-23-6 continued. The cellular geoweb was backfilled with a layer of topsoil. Herbaceous seed and biodegradable erosion control matting were placed and the area was replanted with trees and shrubs. The re-installation of the vacuum cleaner was completed. The temporary fence was re-installed on the riverbank of the area. A 2.5-inch base coat of paving was installed on the parking lot of the area affected by the pipe repair. Per agreement with the property owner of Parcel I8-23-6, the final coat of paving will be installed at the later date. The temporary access road which was built for the outfall repair purposes will be left in place and used during the spring 2004 planting activities.

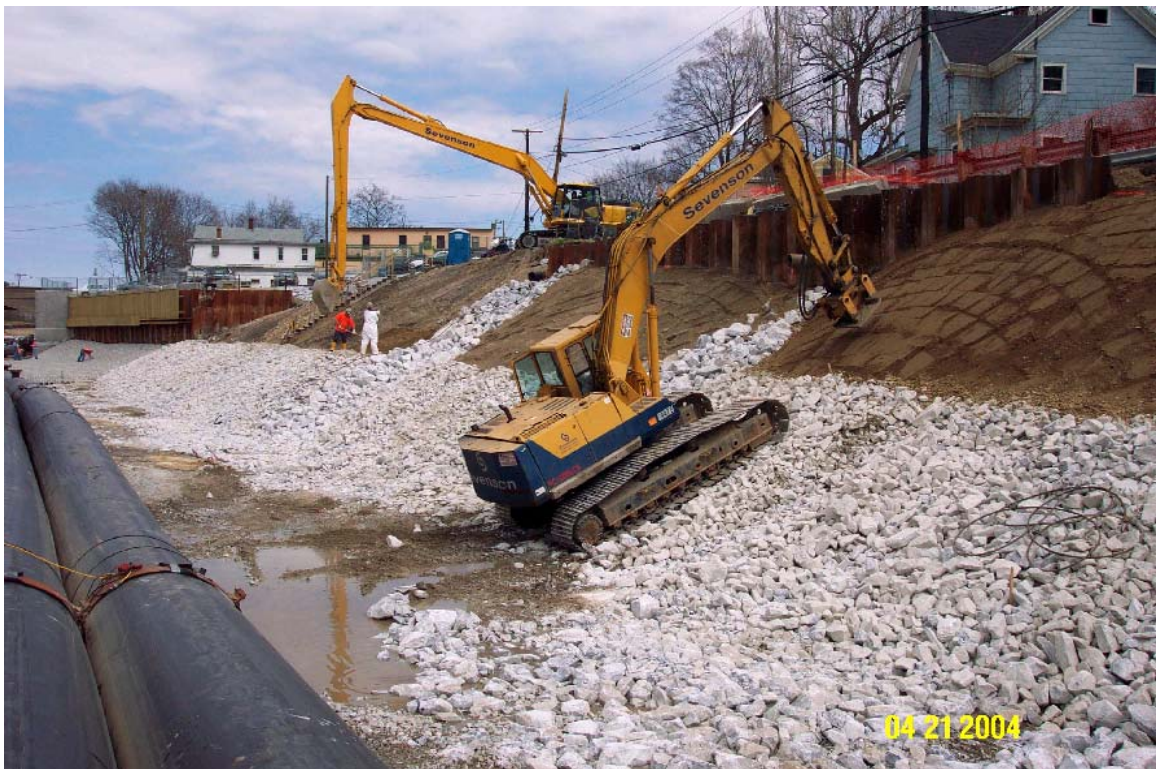
Photograph 4 – Backfilling Activities in Cell 15E

Backfilling also continued on the east riverbanks in Cells 14 and 15, common fill, topsoil, herbaceous seed and biodegradable erosion control matting were placed on the riverbanks above the ACB and the rip rap. The areas with steep riverbank in Cell 15E were restored at 1.5H:1V slope and stabilized with cellular geoweb.

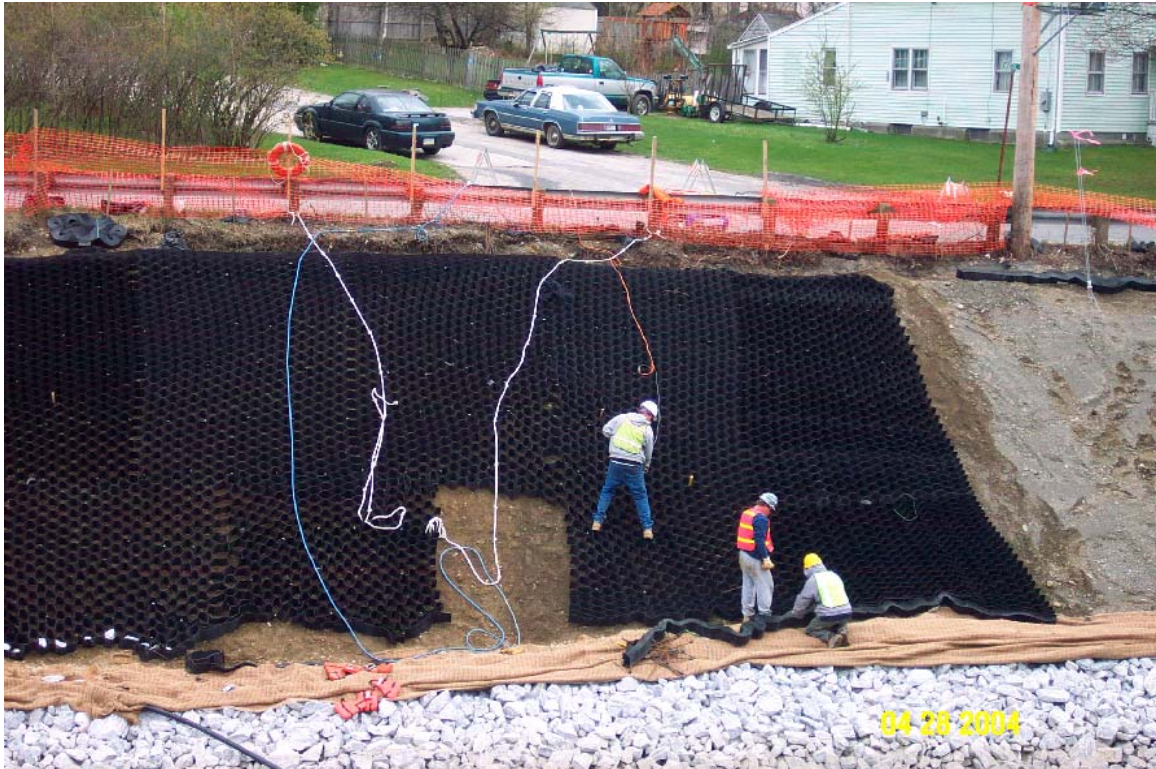
Photograph 5 – Installation of the Cellular Geoweb in Cell 15E

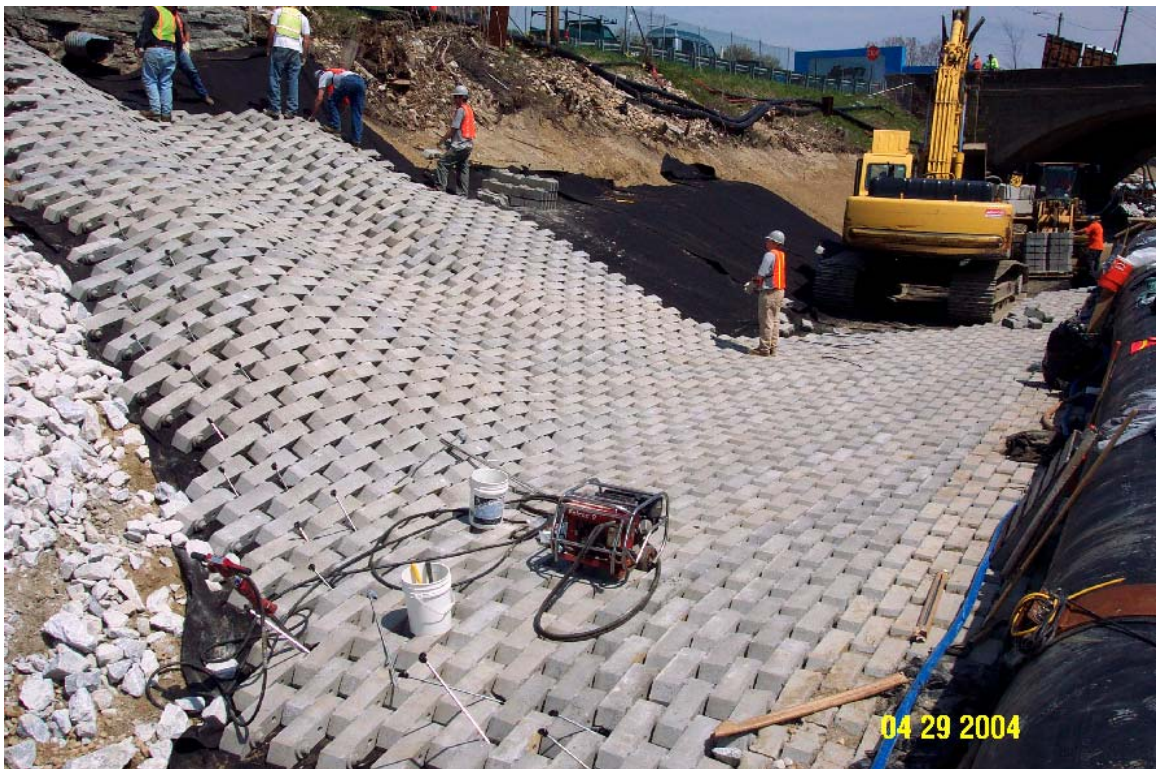
Photograph 6 – Installation of the Articulated Concrete Block in Cell 14W

During the last week of April, the backfilling activities continued in Cells 14W and 15W. However on April 26, 2004 due to the high river flows and forecasted rain, all equipment was removed from Cells 14 and 15. The stop logs were removed from the temporary dam and the area downstream of the dam was flooded. By April 28, 2004 the water levels receded, stop logs were added to the dam and dewatering of Cells 14 and 15 was completed. Once the dewatering was done, backfilling activities were re-started. The placement of the structural fill, grading and compaction in the first 185 feet of the riverbed and riverbank was completed and the installation of the ACB was initiated. Geotextile and ACB with PET cable between the blocks were installed. The ACB was then anchored with Manta Ray anchors. Backfilling activities were initiated in the remaining 345 feet of the riverbed and riverbanks in Cells 14 and 15.
